Re: Geotechnical Assessment – Future Lot 2
Cowlitz County Parcel 508890100
SCOTT HILL ROAD, Woodland, WA 98674

Strata-Design Project No. 20-0212.2

Woodland Residential Development, Future Lot 2

Geotechnical Assessment – Engineer’s checklist

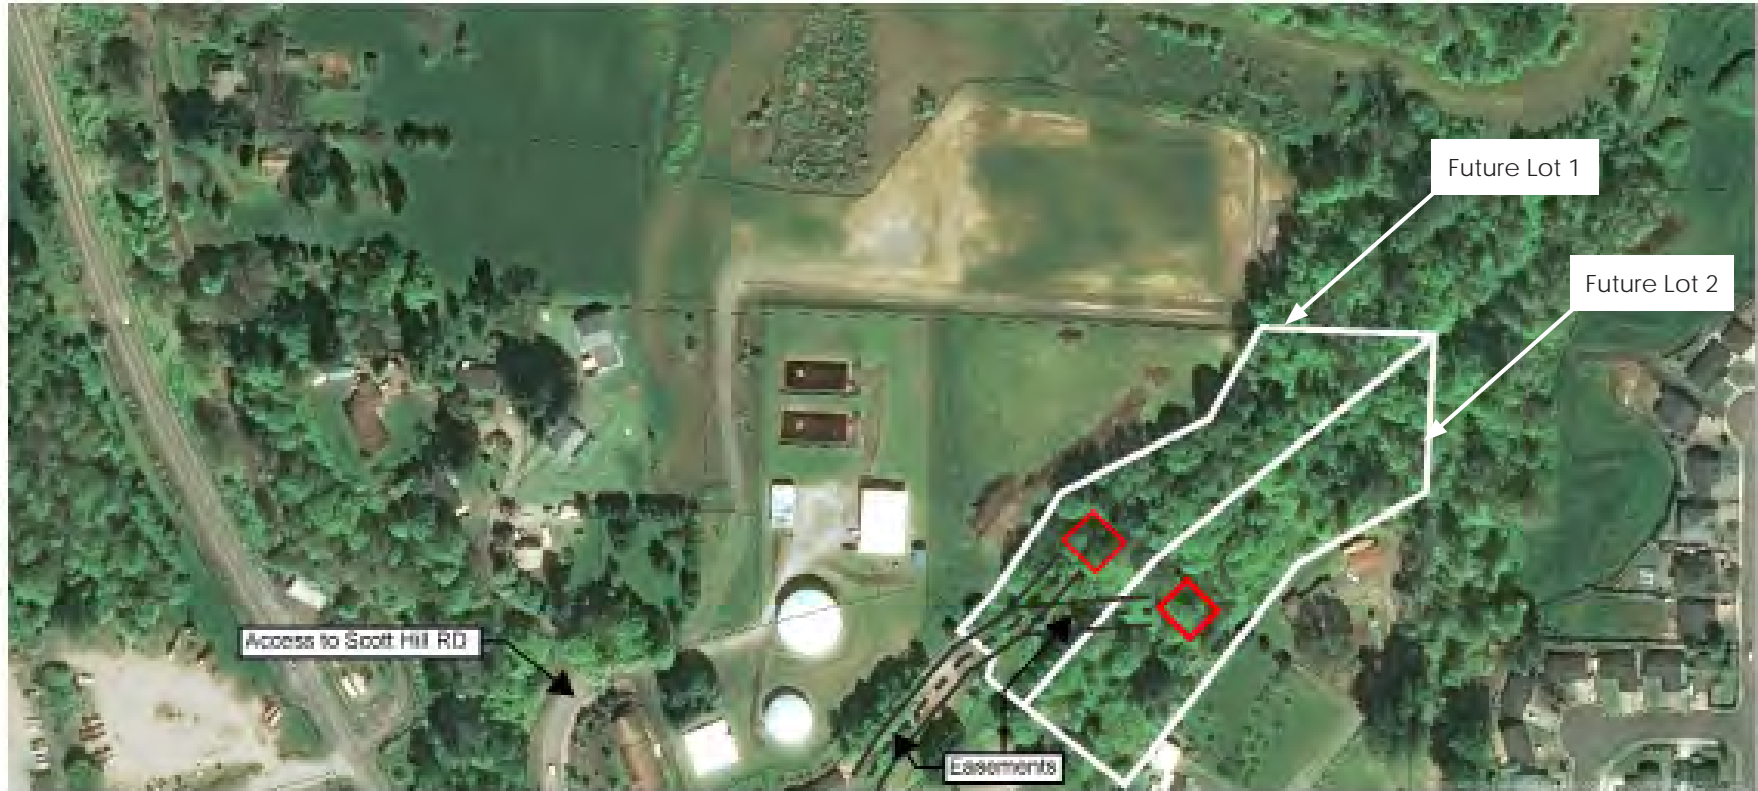
Figure
2

CONCEPTUAL SHORT PLAT-DEVELOPER PROVIDED MAP
Woodland Residential Development, Future Lot 2

We understand that you have purchased the property with the intent of building on the Lot 2 site (Figure 3). Figure 3 shows a LIDAR view with topography of the site and active landslides superimposed on the LIDAR image. As shown on Figure 2, we identify two proposed building sites on the parcel (Future Lot 1 and Future Lot 2). This report consists of an assessment of Future Lot 2. An assessment for Future Lot 1 has been completed and released to you under a separate cover on December 7, 2020.

Project Description – Figures 2 and 3 shows a conceptual layout of the parcel and the proposed residential improvements. The general description of the residence and surrounding construction is included in the above text.

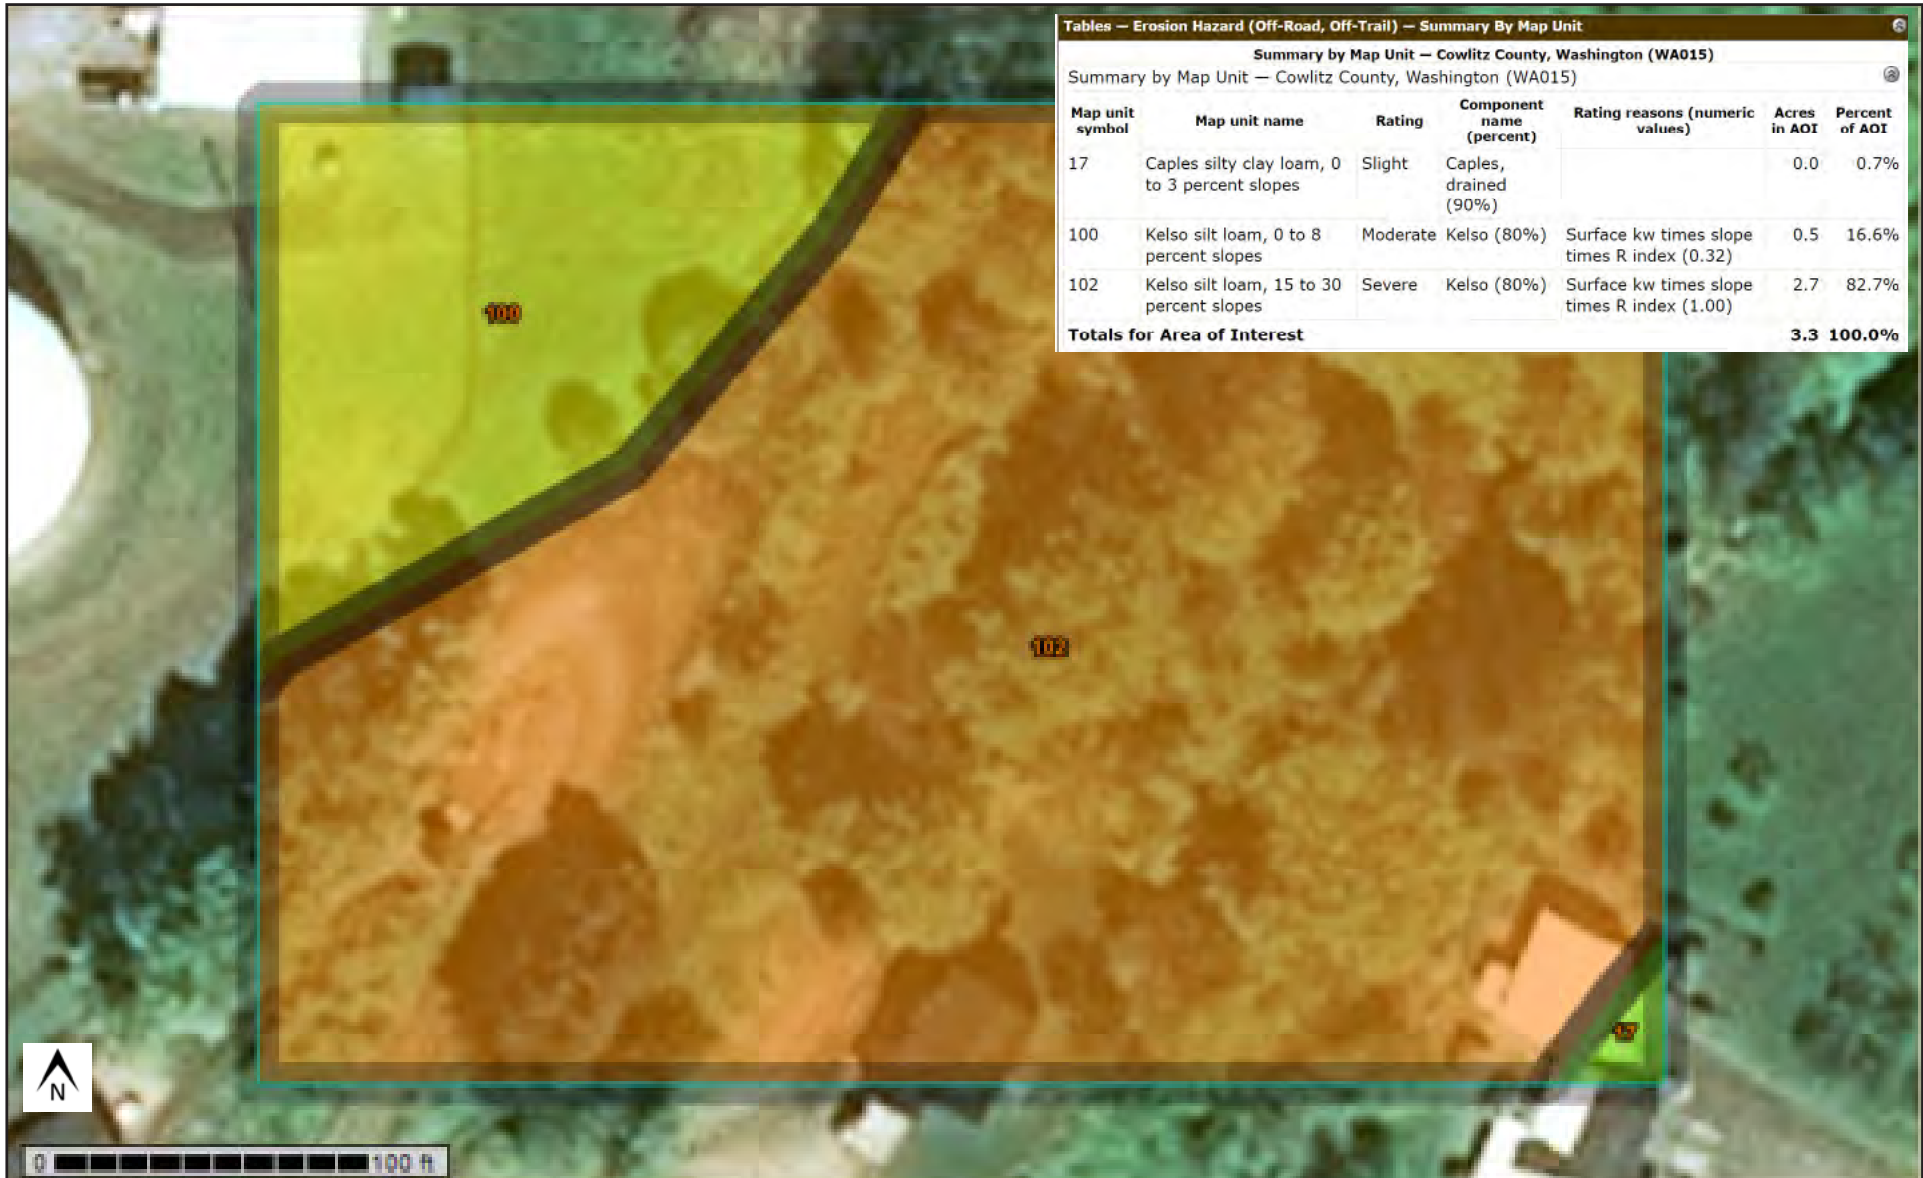
Recent geologic mapping by the U.S. Geological Survey (Evarts, 2004²) shows the terrace is underlain by the silt and sand facies of the Late-Pleistocene age glacial outburst deposits, also known as the Missoula Floods (map unit Qfs). The Missoula Flood (MF) deposits originated from repeated ice dam failures in front of glacial Lake Missoula in Idaho and western Montana; the floods spanned a period between 17,000 and 13,000 years ago. Figure 4 shows the mapped geologic units. Figure 5 shows that the mapped erosion hazard is “Severe”. Figure 6 shows a comparison between the 2010 and 2019 lidar maps.

Our previous drilling indicates that the failure surface at mid-slope is interpreted to be about 50 feet deep¹. Figure 6 – Vertical Elevation Heat Map, shows that the flattened portion of the building site has not moved significantly between 2010 and 2019. Recent monitoring of the inclinometer casing carried out on 7/31/20 and 10/27/20 indicates no movement and extends the no movement finding (since the 2010 map) to October of 2020. Groundwater monitoring indicates levels hovering around 61 feet depth in the lower aquifer. A possible upper aquifer was identified at about 33 feet depth although no monitoring casing was installed at that depth.

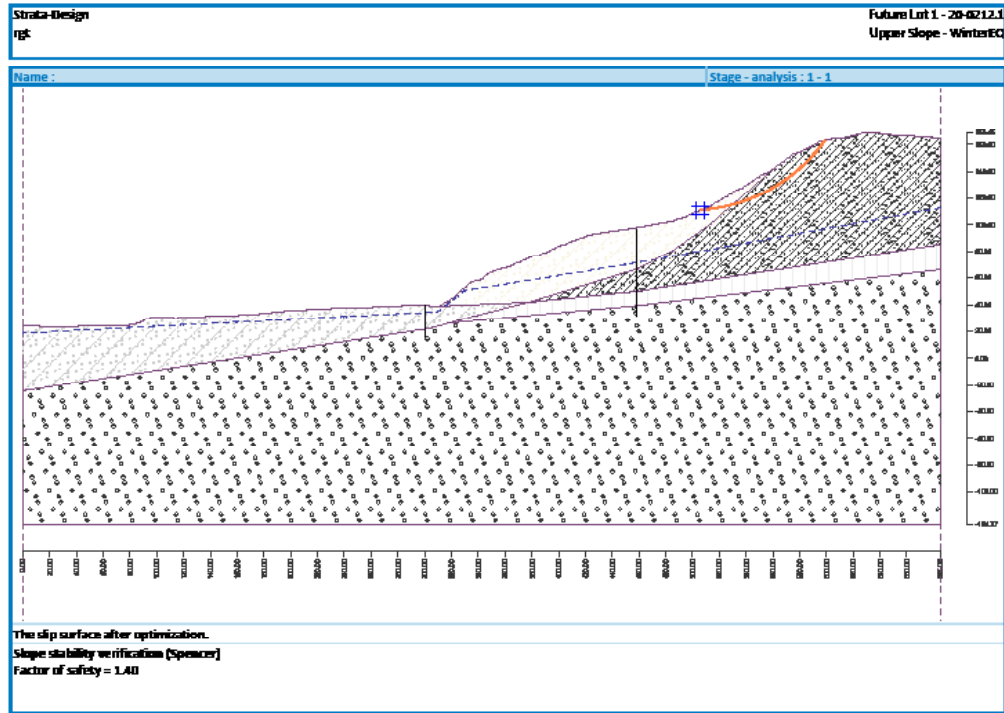
The attached stability analysis (Figure 7) shows that the upper slope of the scarp is reasonably stable (FS = 1.4). The overall calculated static FS of the entire slope is 1.16. Under seismic loadings equal to $\frac{1}{2}$ the PGA^{1,3}, the FS is less than 1.0, thus any residence should be built to remain standing in an earthquake or significant landslide movement (for life safety) but the structure would likely not be useable after the design seismic event or larger movement. The soil parameters for the FS calculation were developed in our previous report¹. Overall, as shown, landslides such as that existing on your parcel are typically difficult and prohibitively expensive to stabilize for residential use. As such, if building in these areas is contemplated, selective siting, minimal ground disturbance, avoiding drainage changes and building appropriate structures is critical to avoiding large differential movements and potential catastrophic structural failures. In the case

Soil parameters - effective stress state

No.	Name	Pattern	φ _{eff} [°]	c _{eff} [psf]	γ [pcf]
1	Landslide Mass - Mobilized St. Helens Deposits		25.00	100.0	120.0
2	Alluvium		21.00	50.0	118.0
3	Dense Alluvium		35.00	0.0	125.0
4	Dense St. Helens Flood Deposits		32.00	150.0	125.0
5	Wall Backfill		30.00	1000.0	120.0
6	Silt		28.00	100.0	120.0

of the proposed construction at Lot 2, the base of any foundation elements would need to penetrate a minimum of about 40 feet below the base of the home to develop the minimum FS = 1.16 level. Further, appropriate depth and capacity tie-backs socketed back into the scarp materials to the north would be required. The pile and tie-back design are not part of this report but can be developed once you select a house footprint and location.

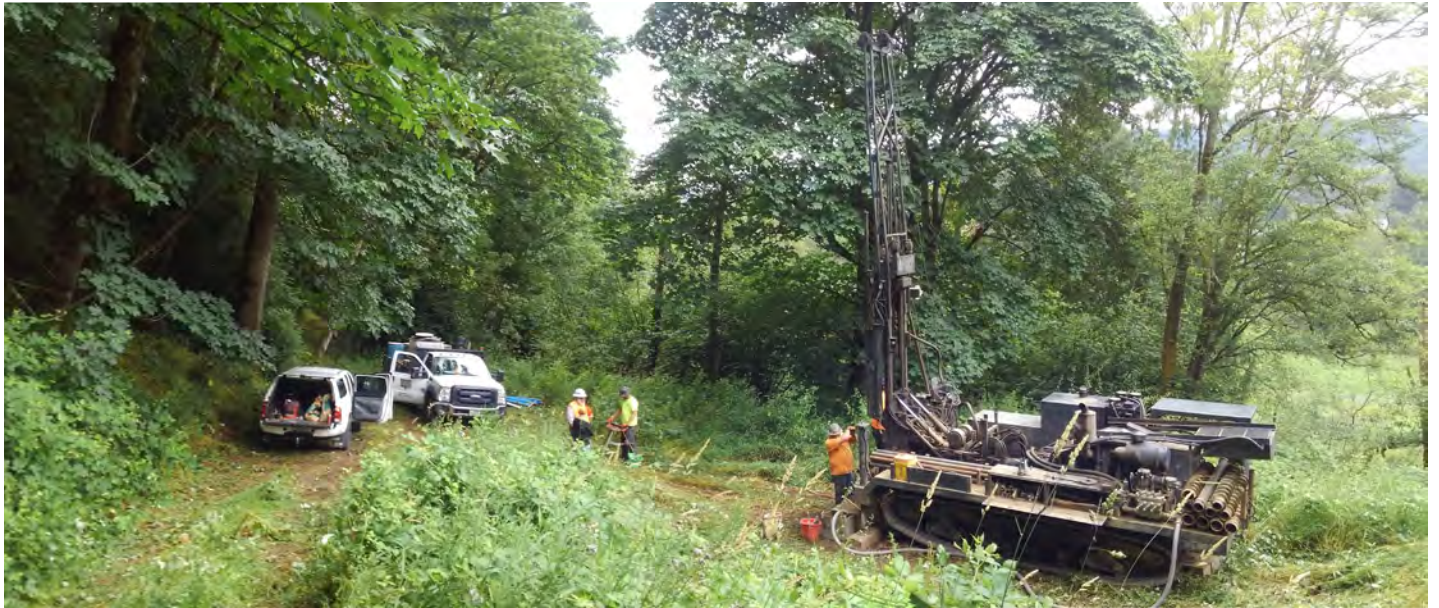
Photo
1

Description of Photograph:
General Drilling Operation at B-1

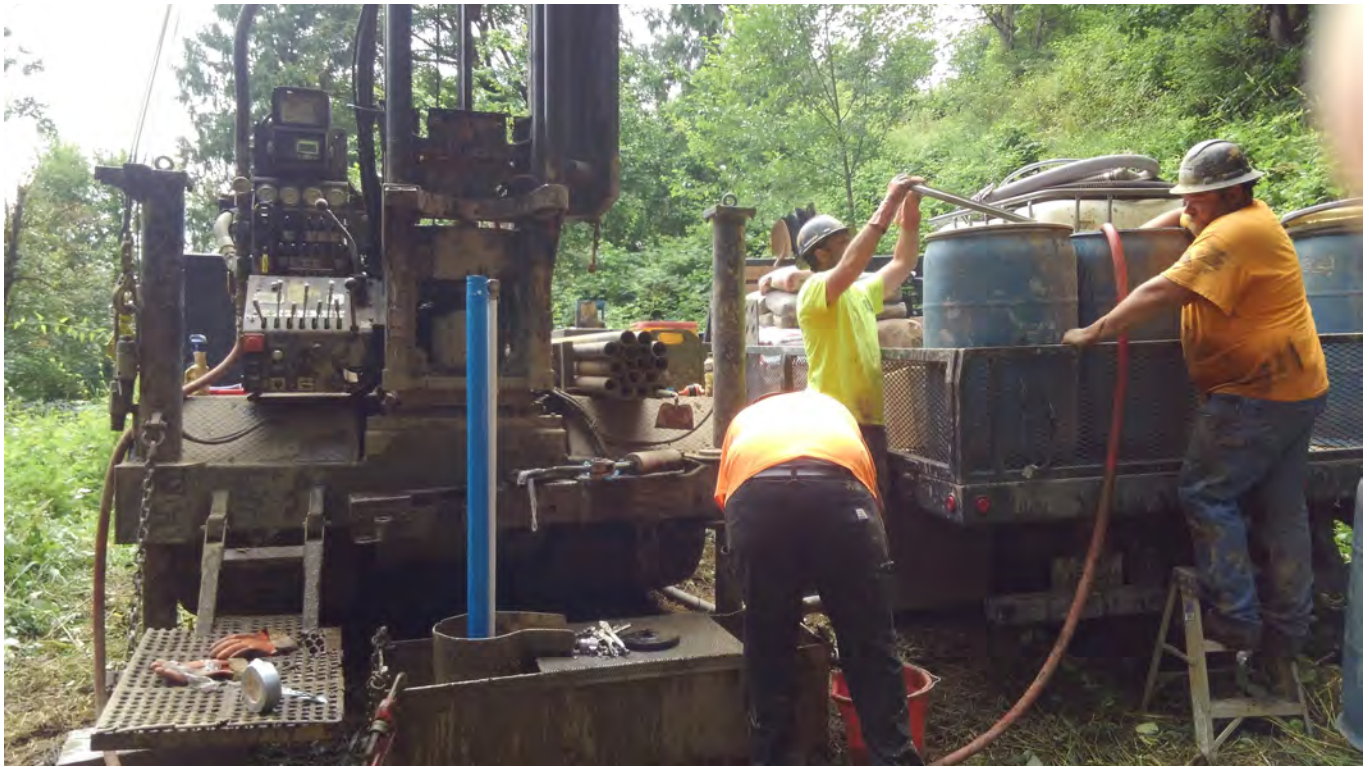
Photo
2

Description of Photograph:
Inclinometer Pipe Installation
