# Geotechnical Investigation

560 Bozarth Avenue  
Woodland, Washington

Prepared for:  
Windsor Engineers  
24 January 2022

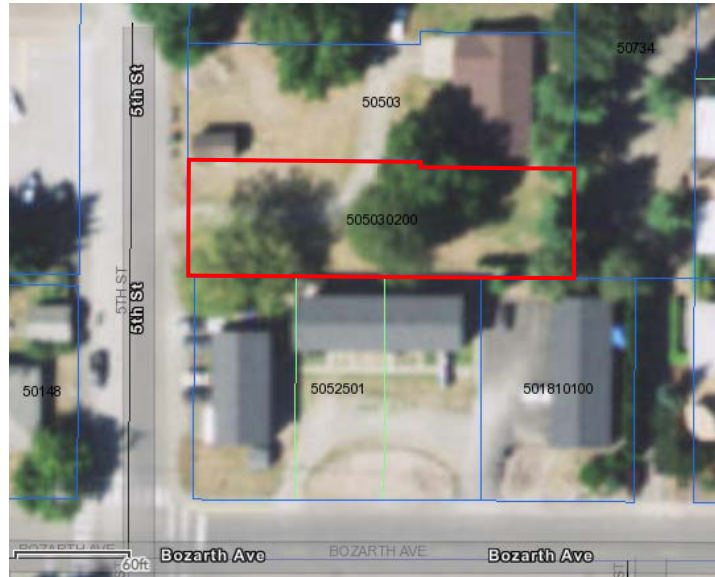
Figure 1: Existing conditions at the subject site, aerial image collected from Cowlitz County Maps Online

The subject site encompasses 0.27 acres across a single Cowlitz County tax parcel. A gravel driveway extends into the subject site from 5<sup>th</sup> Street; this driveway was historically utilized

to access the adjacent single-family dwelling (620 5<sup>th</sup> Street). A new gravel driveway has been completed within the north-adjacent parcel for the ingress/egress for the dwelling. The majority of the parcel contain short cropped grasses. A large tree was recently felled within the site, and large trunk and stump remnants still remain on site. A hedge is situated at the southeastern margin of the site. A short chain link fence extends along the eastern margin of the site.

Slopes on site are very low, with an elevation change of less than two feet across the site. No standing or flowing water is mapped on site. No standing or flowing water is observed on site. No structures are located within the subject site.

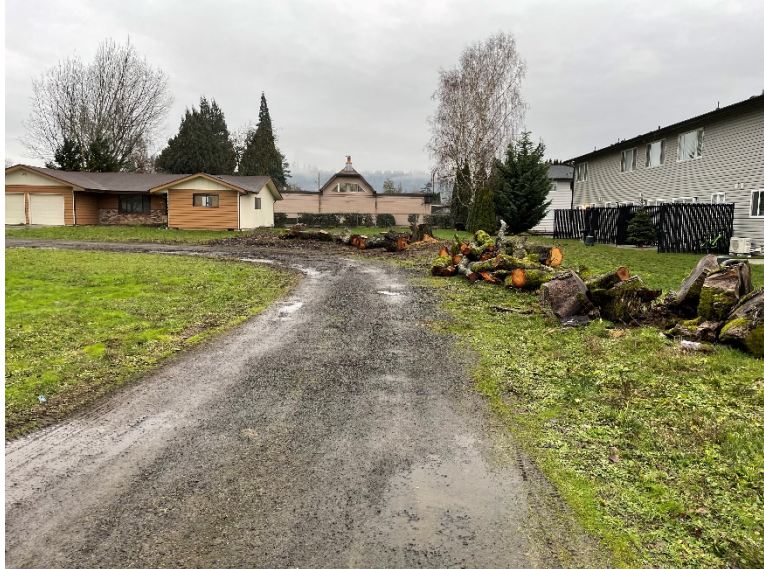
Figure 2: Existing conditions at the subject site, image collected January 11th, 2021.

RSS conducted field explorations of the subject on January 11<sup>th</sup>, 2022. RSS traversed the site on foot. RSS found the slopes to be nearly level, as described by the above listed references. Trunk and stump remnants from a recently felled large tree were found near the center of the site. The driveway dominates the western end of the site, while a short-cropped grass lawn dominates the eastern end of the site.

The driveway entering the property is gravel and is relatively smooth. Minor puddles and one small depression were observed in the gravel driveway. Heavy rain showers preceded the site visit conducted by RSS. Beyond the northern edge of the maintained gravel driveway, the gravels extend below a thin layer of organics and
