CRITICAL AREAS REPORT

November 1, 2020

Woodland Creek Delineation *Woodland, Washington*

Ecological Land Services, Inc.

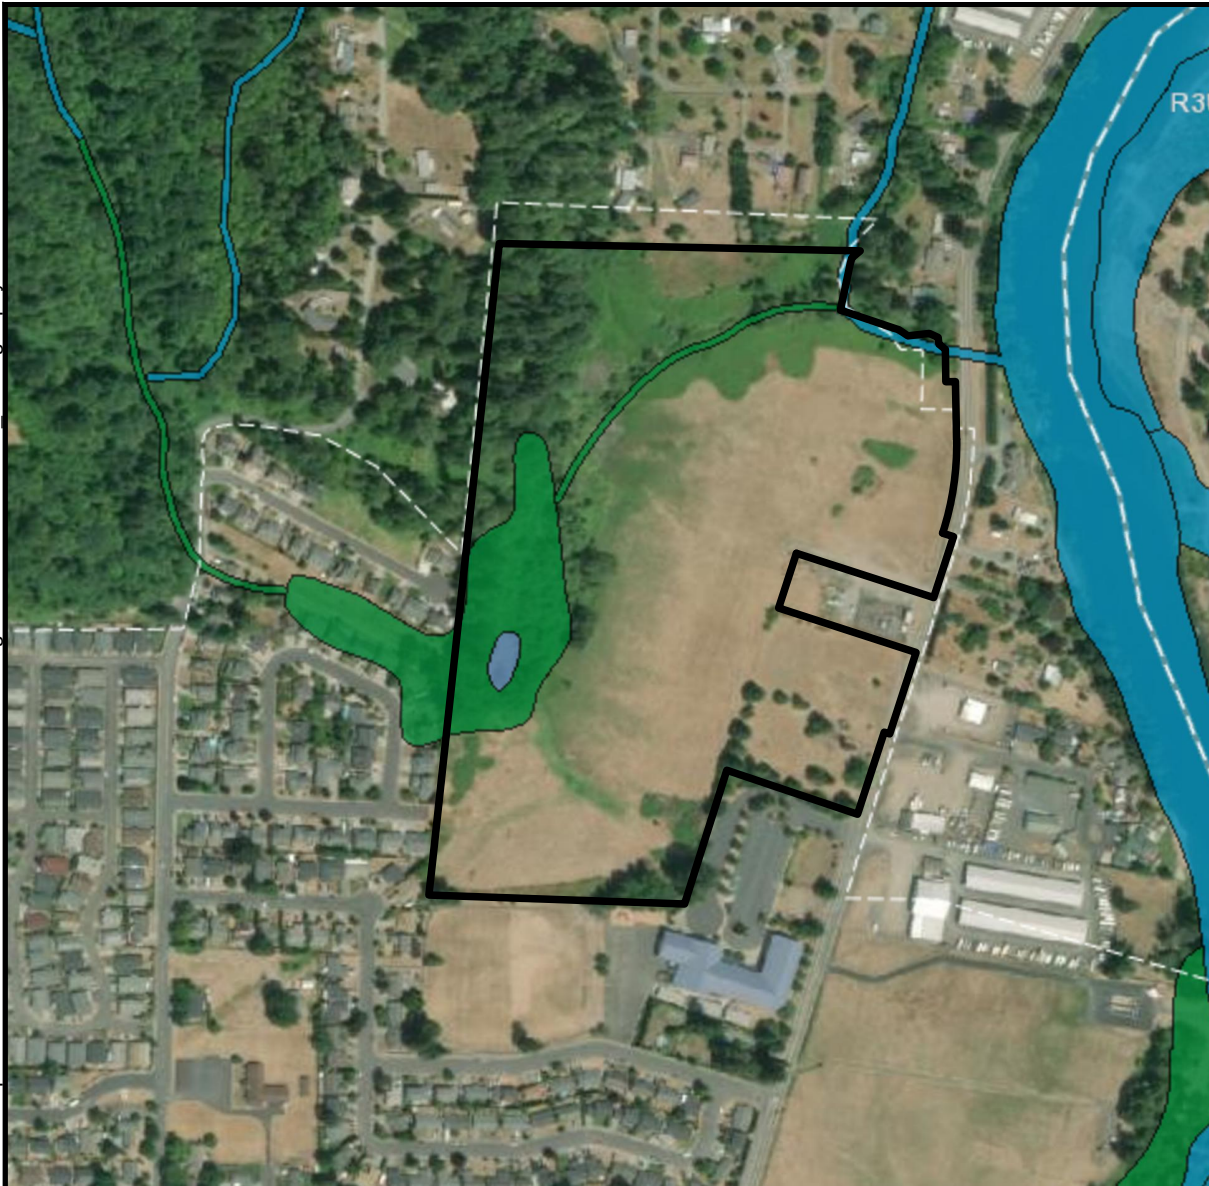
Figure 4
 NATIONAL WETLANDS INVENTORY MAP
 Woodland Creek
 Hinton Development LLC
 City of Woodland, Cowitz County, Washington
 Section 7, Township 5N, Range 1E, W.M.

Mapped wetlands indicated onsite by US Fish & Wildlife Service.
