LEVEL I HABITAT ASSESSMENT

**Guild Road Permitting
Cowlitz County**
Woodland, Washington

Prepared for
Part IV Properties, LLC
12313 NE 99th St.
Vancouver, Washington 98682
(360) 921-4525

Prepared by
Ecological Land Services
1157 3rd Avenue, Suite 220A • Longview, WA 98632
(360) 578-1371 • Project Number 1353.02

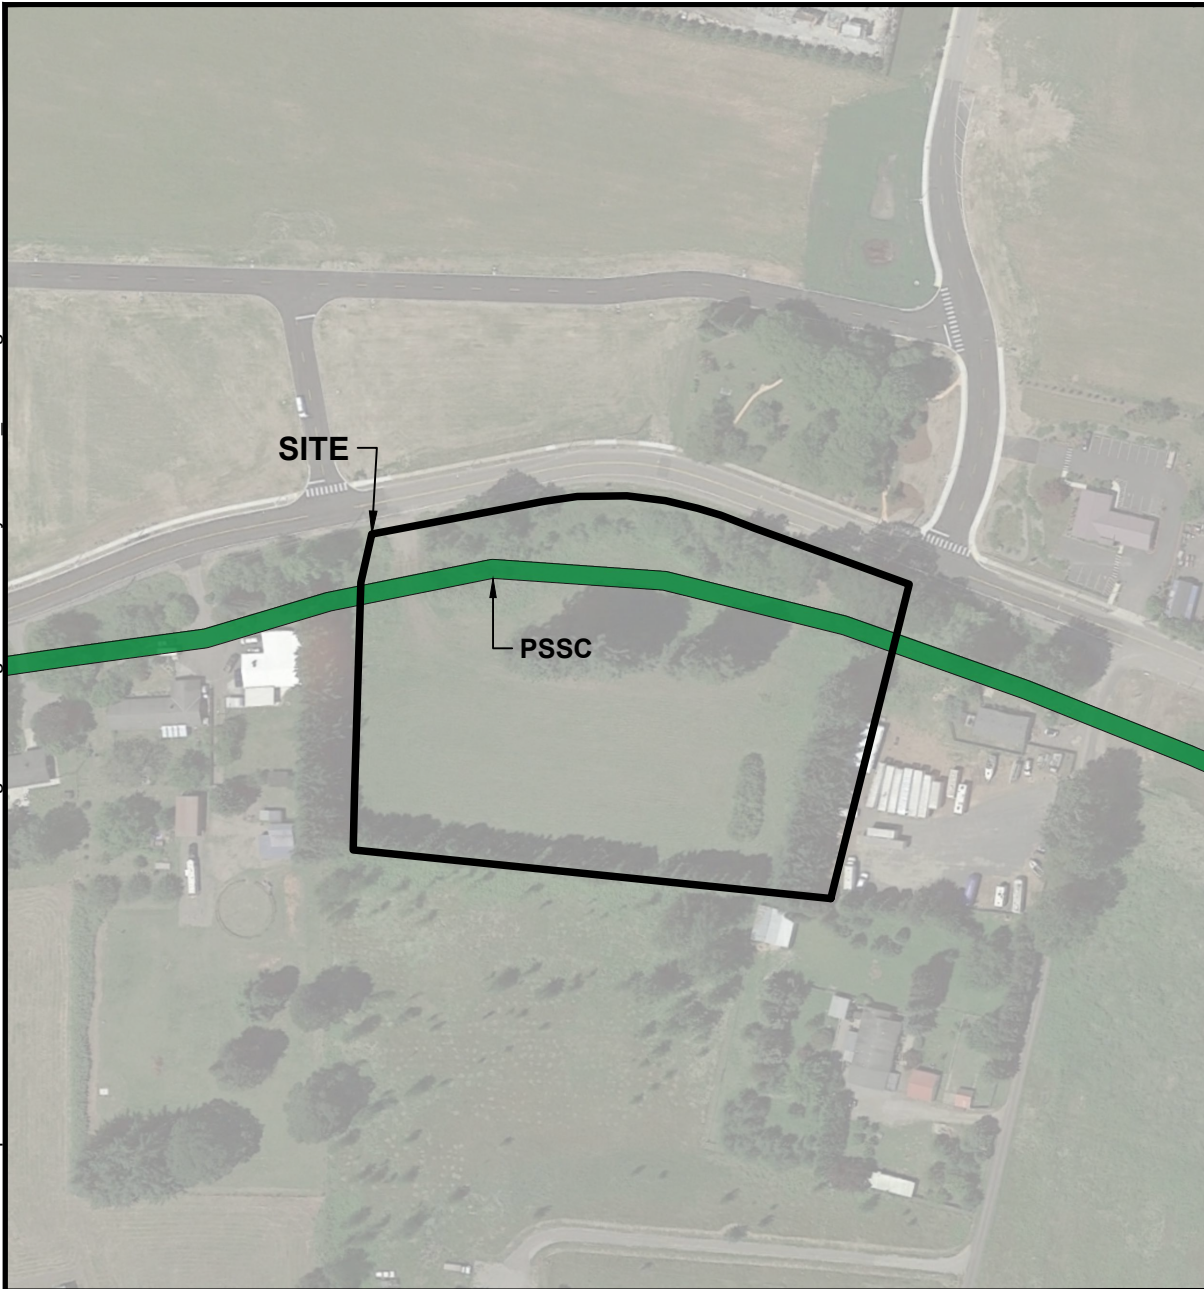
Figure 5
USFWS NATIONAL WETLANDS INVENTORY
 Guild Road Permitting
 Part IV Properties, LLC
 Woodland, Cowlitz County, WA
 Section 14, Township 5N, Range 1W, W.M.

Mapped wetlands indicated onsite by US Fish & Wildlife Service.

The National Wetlands Inventory (NWI) maps a palustrine scrub-shrub seasonally flooded wetland (PSSC) in the approximate location where ELS identified a Type F stream (USFWS 2022b)(Figure 5). The findings of the ELS study were mostly consistent with the NWI map in respect to location; however, the wetland is Goerig Slough. NWI maps are typically used to gather wetland information about a region and due to the large scale necessary for regional mapping are limited in accuracy for localized analyses.

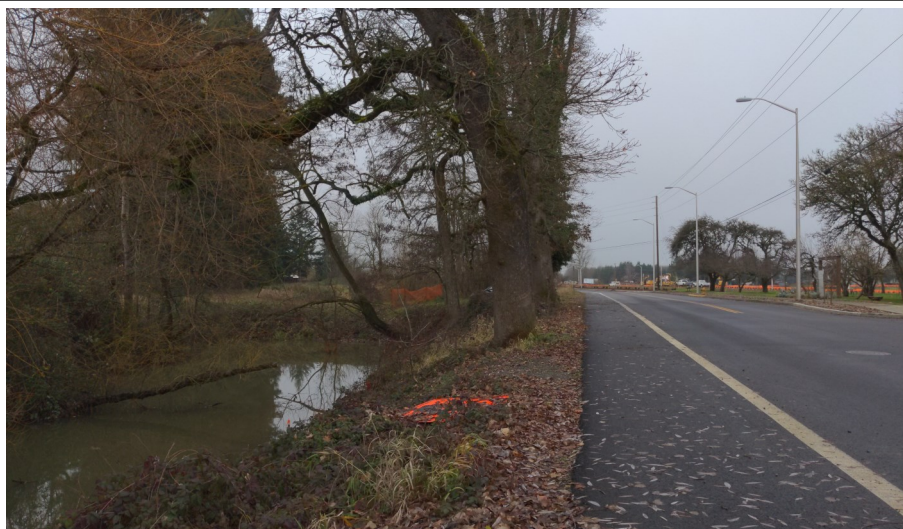
Photo 1. Eastern end of property, looking west.

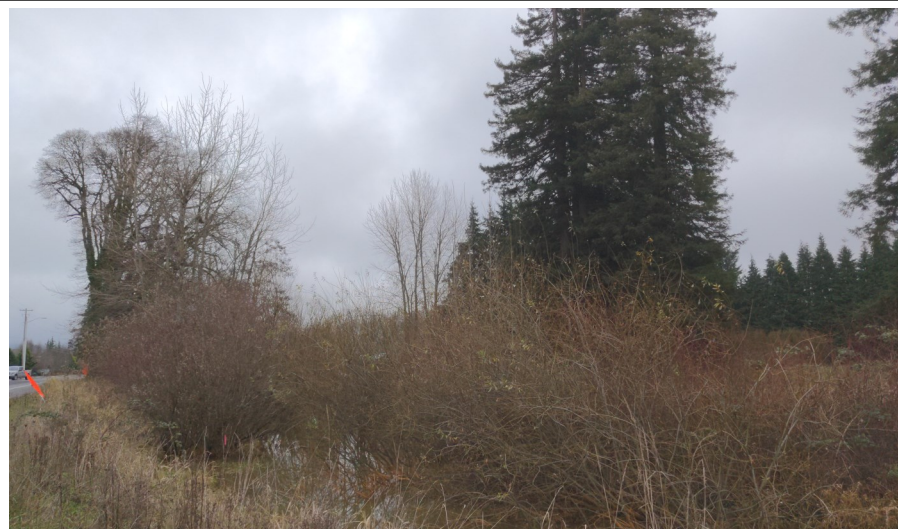
Photo 2. Midway along central slough segment, looking southeast.

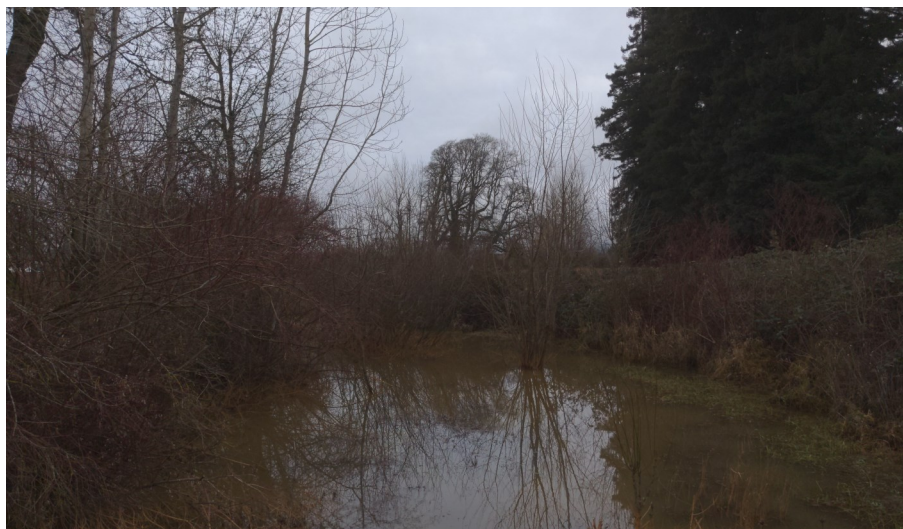
Photo 3. Central slough segment from western end, looking east.

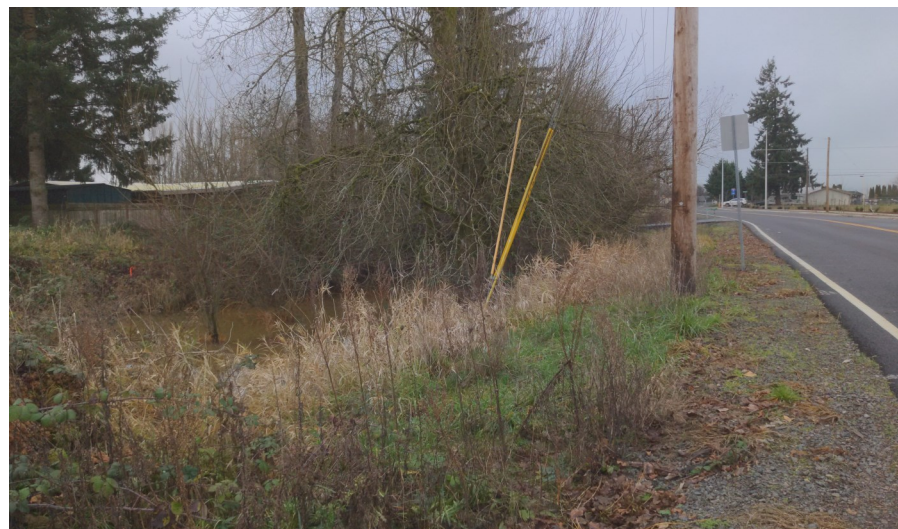
Photo 4. West end of property, looking west.

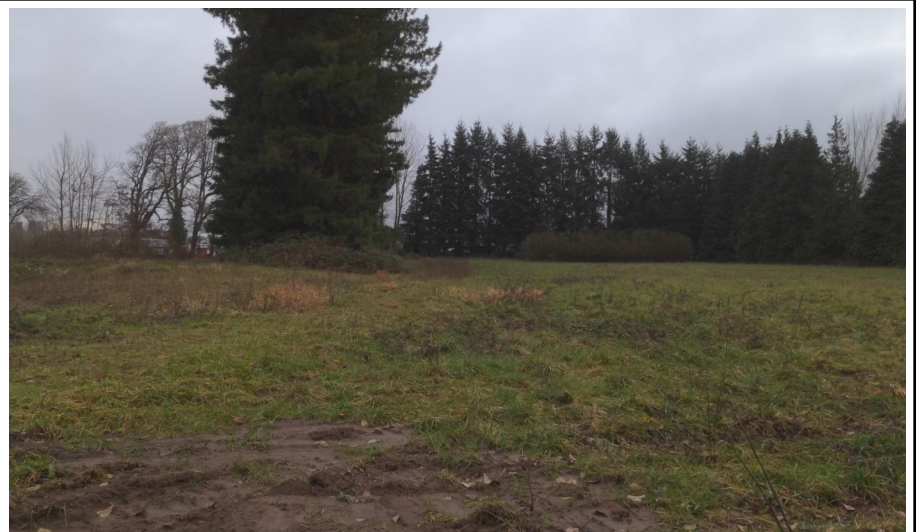
Photo 6. Looking east at redwoods from western end of site.

Removal of the redwood trees is necessary as they will become a significant hazard to site development and future workers. Several tree-sized branches and one treetop blew off between the December 2021 and January 2022 site visits. Removing some of the trees, particularly ones at either end of the row, will likely leave the others more susceptible to windthrow; therefore, it is necessary to remove all the redwoods for safety reasons.

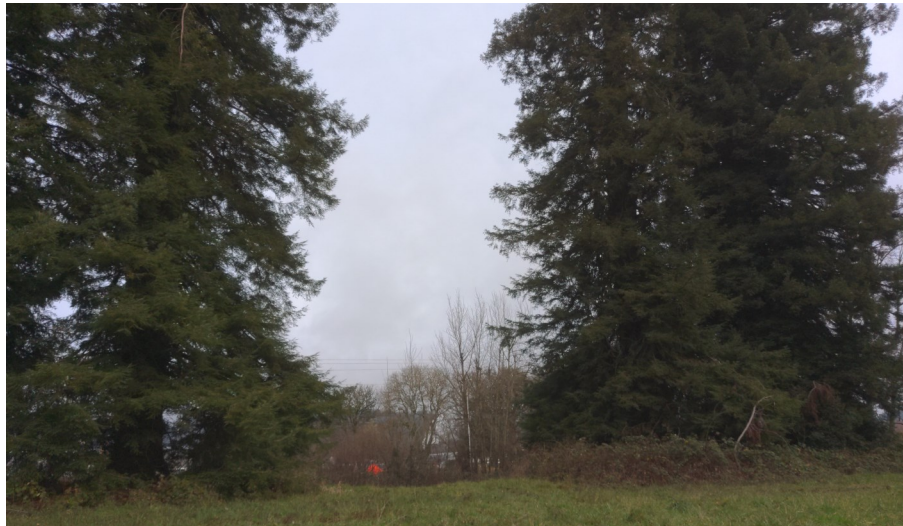
Photo 7. Gap between redwoods, looking north.

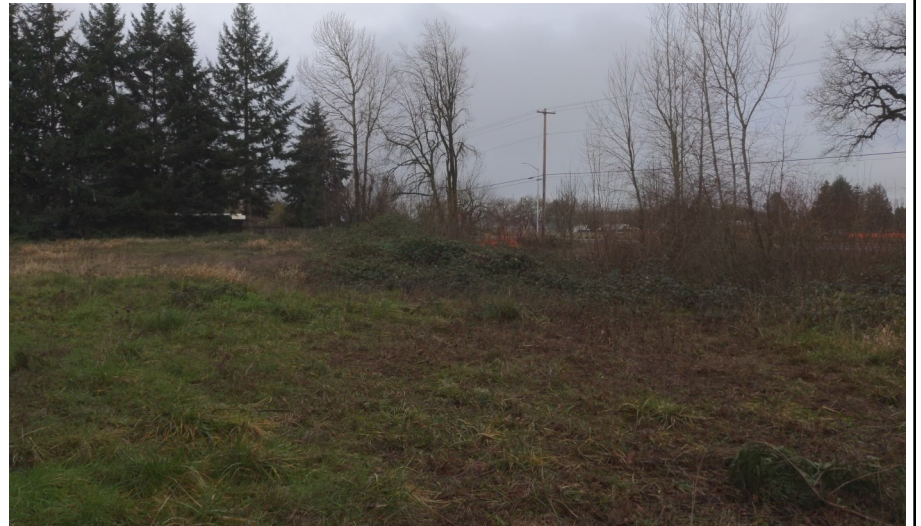
Photo 8. Looking northwest at blackberry area located in southwest portion of central segment.
