Preliminary Stormwater Management Report

Woodland Library
411 Lakeshore Drive
Woodland, Washington 98674

Prepared for:
Fort Vancouver Regional Libraries
1007 East Mill Plain Boulevard
Vancouver, Washington 98663

December 8, 2022
PBS Project 71959.000

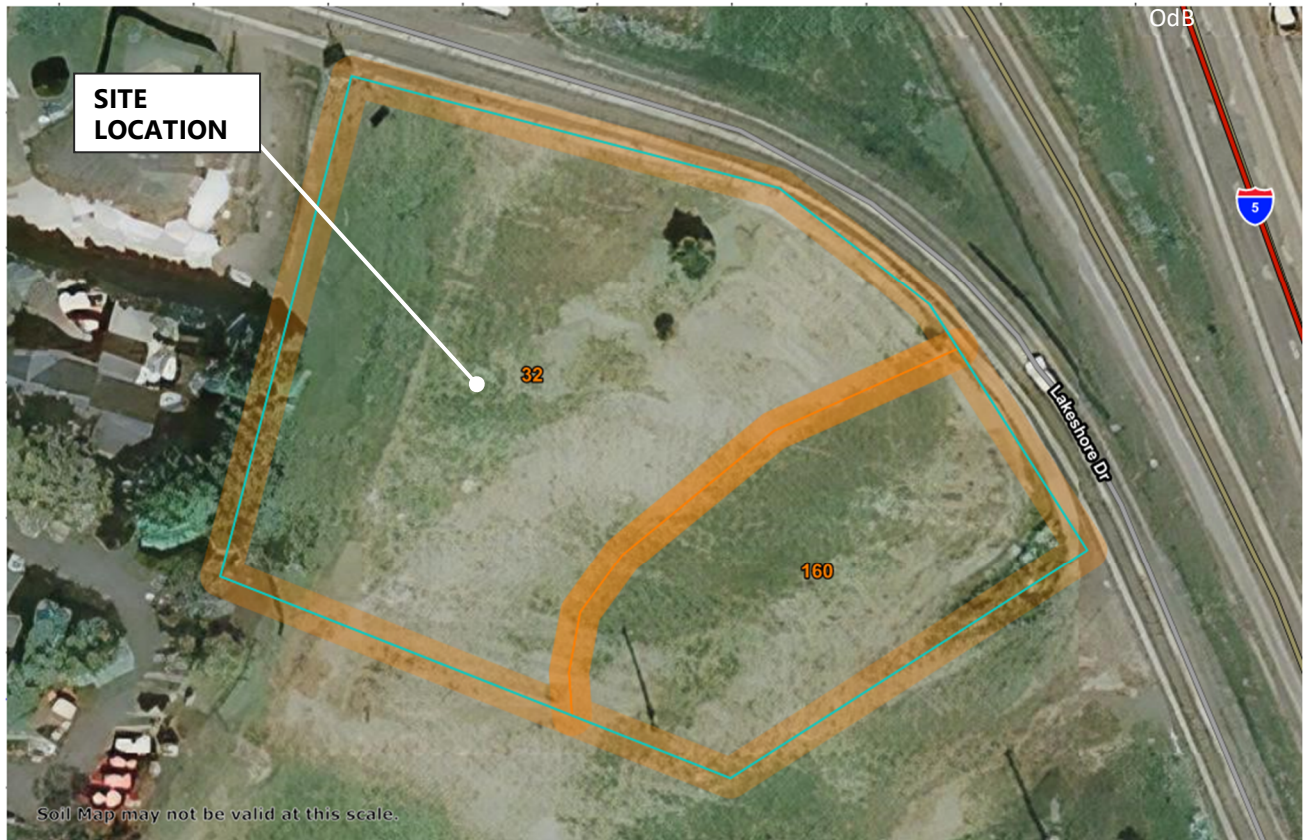
Figure 2. Soils Map

USDA Web Soil Survey – NTS

Soil Type: Clato silt loam (32), 0 to 3 percent slopes – Hydrologic Soil Group B
Pilchuck loamy fine sand (160), 0 to 8 percent slopes – Hydrologic Soil Group A

The Natural Resources Conservation Service (NRCS) soils map indicates the onsite soils to be Clato silt loam and Pilchuck loamy fine sand. Clato silt loam is classified as hydrologic soil group B. Pilchuck loamy fine sand is classified as hydrologic soil group A. The geotechnical investigation approximated groundwater to be present at a depth of 9 feet bgs. Infiltration testing at two test pits resulted in a rate of 28 inches per hour. A factor of safety of 4.5 was used and the derived design infiltration rate used was 6.2 inches per hour. The Geotechnical Engineering Report prepared by PBS Engineering and Environmental, Inc. dated September 22, 2022, is in Appendix C of this report.
