This memorandum is detailing updates to the critical areas report for the Oak Village Apartments site which was previously submitted to the City of Woodland on July 1, 2021. Staff members from ELS, AKS, and George Fornes from the Washington Department of Fish and Wildlife (WDFW) conducted a site walk on Tuesday July 28, 2021 to evaluate the proposed mitigation strategy and to address concerns with content of the critical areas report. The following subjects are discussed below:

**PROPOSED CONDITIONS SITE MAP  
 OAK VILLAGE APARTMENTS  
 41ST AVENUE LLC  
 WOODLAND, WASHINGTON**

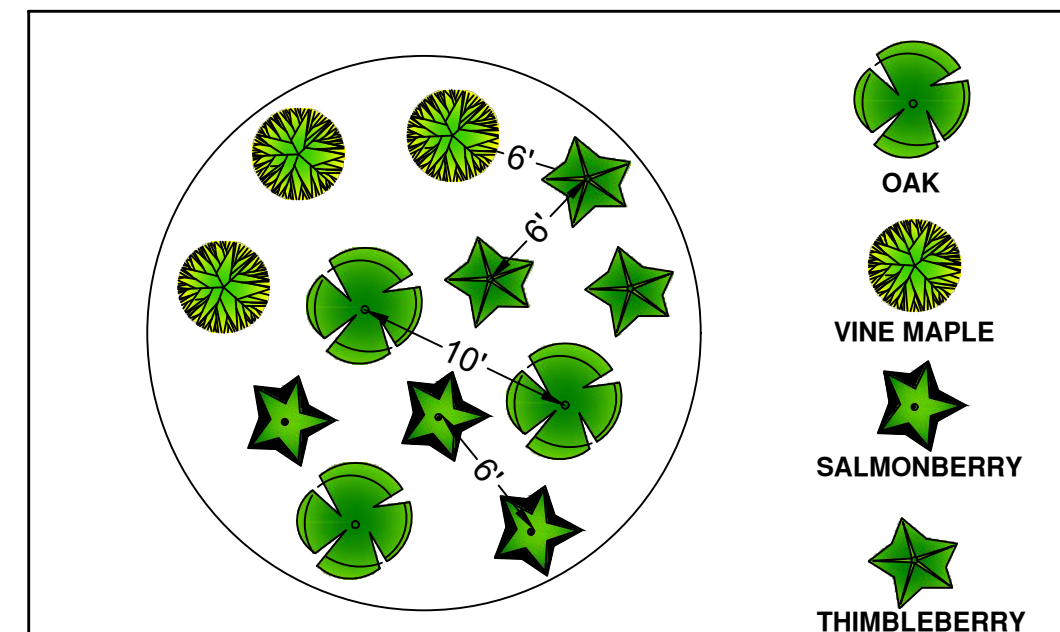
**OAK PLANTING DETAIL**  
 NTS

**NOTE:** Plants are not to scale and locations are approximate as shown. Actual planting locations will be determined in the field, with consideration to the listed spacing and density to produce the most natural appearance possible.
